Wednesday, 3 April 2024

Reference: JN7174

**Quantified Tree Risk Assessment Report on Ten (10) trees at Kyneton Show Grounds
184 Mollison Street Kyneton 3444.**

Quantified Tree Risk Assessment Report

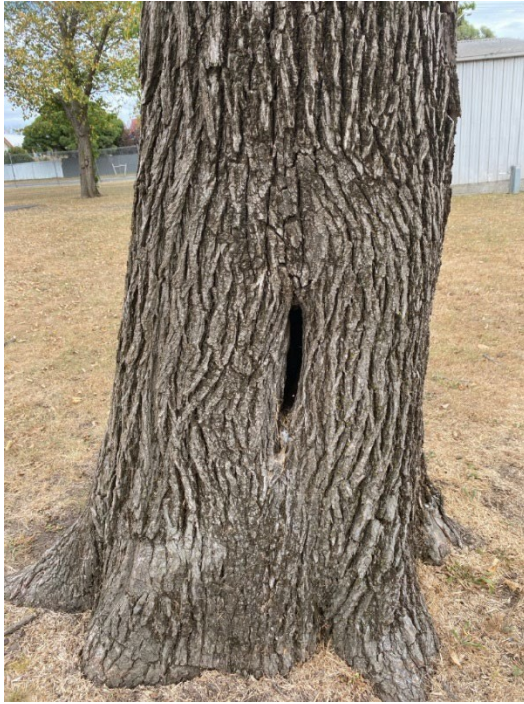
- 3.8 Tree 9 exhibited poor structure due to a highly modified crown, and a trunk with a long-standing cavity forming cracks. The lower trunk was sounded using a nylon sounding mallet comparing acoustic variations in the area adjacent to the cavity with areas presumed to have sound structure. The testing did not confirm unreasonable thresholds for failure although the structure was not able to support the crown reforming. Structure was unlikely to be sustainable without the requirement for excessive maintenance i.e ongoing pruning to maintain heavily modified size/shape. (Refer Figure 2 and Figure 3 below).

Figure 2: Image looking west at Tree 9 showing a cavity in its lower trunk which has cracks appearing adjacent to it (not visible in photo). Image taken on 12th March 2024 by Adam Demler.

1. Removal of Tree 9 including stump grinding to allow for replanting within the same location to maintain planting distance. Stump grinding should be supervised by an AQF Level 5 Arborist or responsible person from Macedon Ranges Council. The replacement should be in a 100L container size to minimise loss to the amenity. The

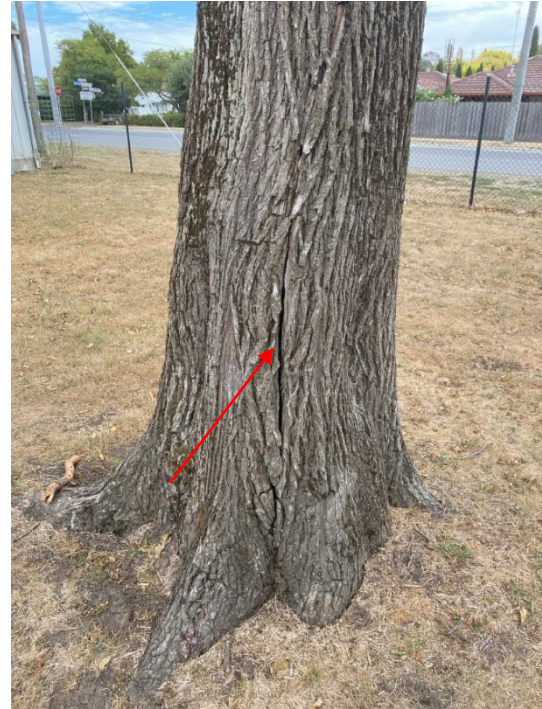
Figure 3: Image looking north at Tree 9 illustrating a longitudinal crack forming adjacent to the previously mentioned cavity. Image taken on 12th March 2024 by Adam Demler.

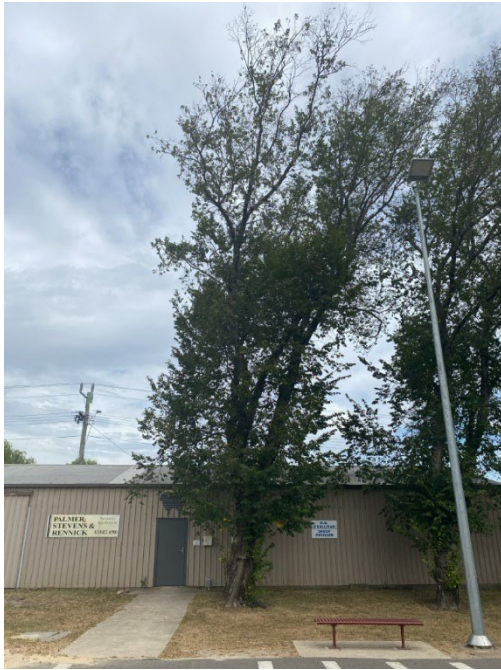
Figure 4: Photo taken of Tree 1 (*Ulmus procera*) in its growing environment. Image taken on 12th March 2024 by Adam Demler.

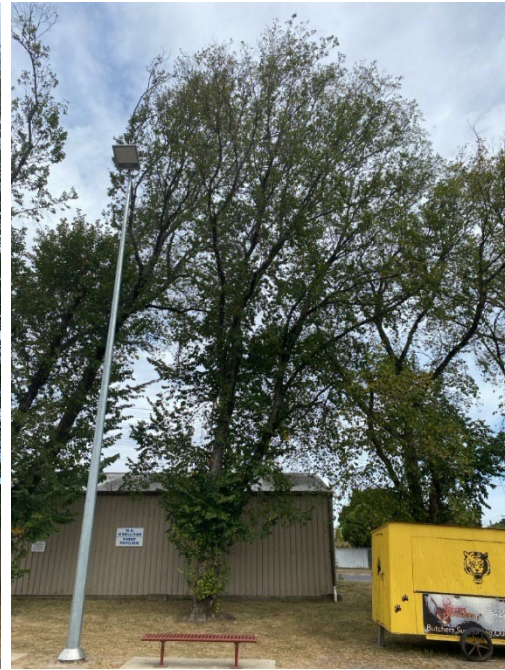
Figure 5: Photo taken of Tree 2 (*Ulmus procera*) in its growing environment. Image taken on 12th March 2024 by Adam Demler.

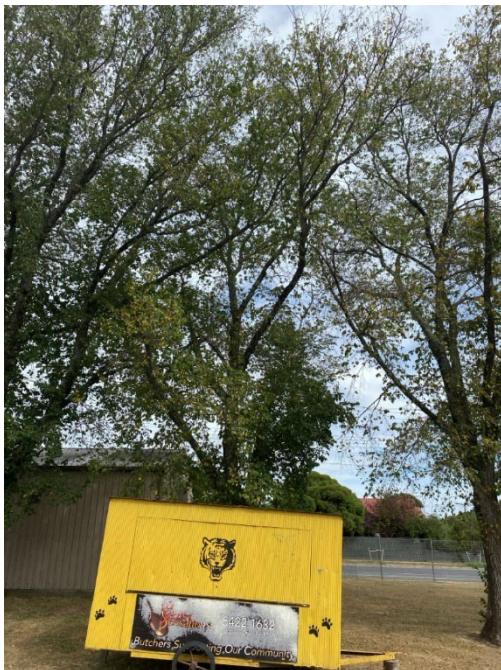
Figure 6: Photo taken of Tree 3 (*Ulmus procera*) in its growing environment. Image taken on 12th March 2024 by Adam Demler.

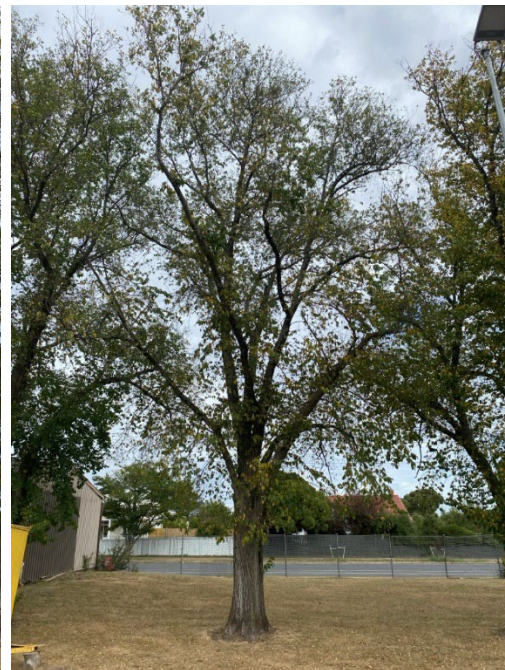
Figure 7: Photo taken of Tree 4 (*Ulmus procera*) in its growing environment. Image taken on 12th March 2024 by Adam Demler.

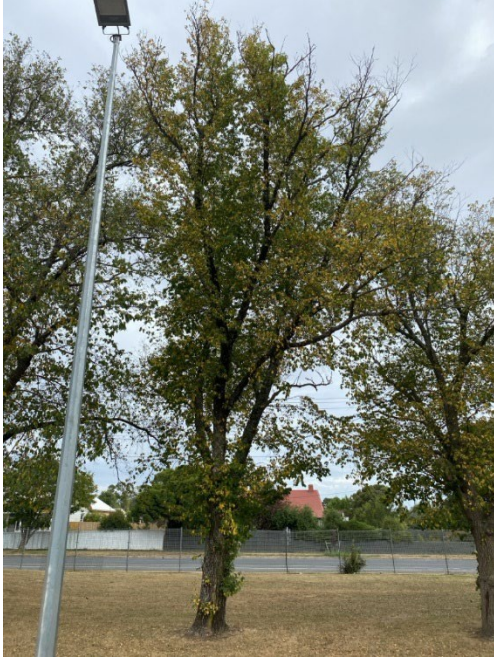
- 3.9 Trees 5 and 10 contained 50-100mm dead branches which could impact areas that are likely to be used for passive and active recreational activities. Deadwood has occurred during the previous 12 months, with minimal signs of new growth observed.

Figure 8: Photo taken of Tree 5 (*Ulmus procera*) in its growing environment. Image taken on 12th March 2024 by Adam Demler.

2. Prune Trees 5 and 10 free of all deadwood, greater than 50mm in diameter (<50mm dia.) back to live branch tissue or suitable branch union, to support crown regeneration through an epicormic response. Pruning should conform with AS4373-2007 Pruning of amenity trees and be undertaken by an AQF Level 3 Arborist.
3. A documented plant health care plan for all trees to include:

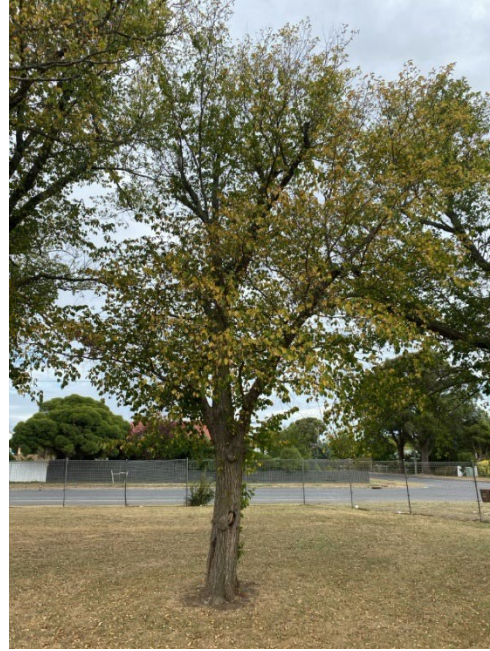
Figure 9: Photo taken of Tree 6 (*Ulmus procera*) in its growing environment. Image taken on 12th March 2024 by Adam Demler.

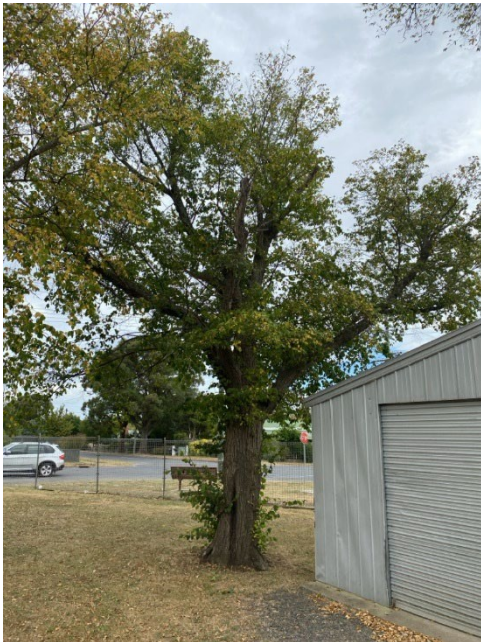
Figure 10: Photo taken of Tree 7 (*Ulmus procera*) in its growing environment. Image taken on 12th March 2024 by Adam Demler.

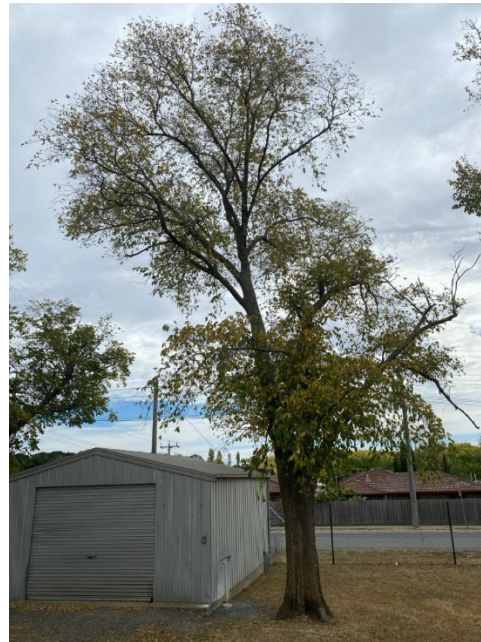
Figure 11: Photo taken of Tree 8 (*Ulmus procera*) in its growing environment. Image taken on 12th March 2024 by Adam Demler.

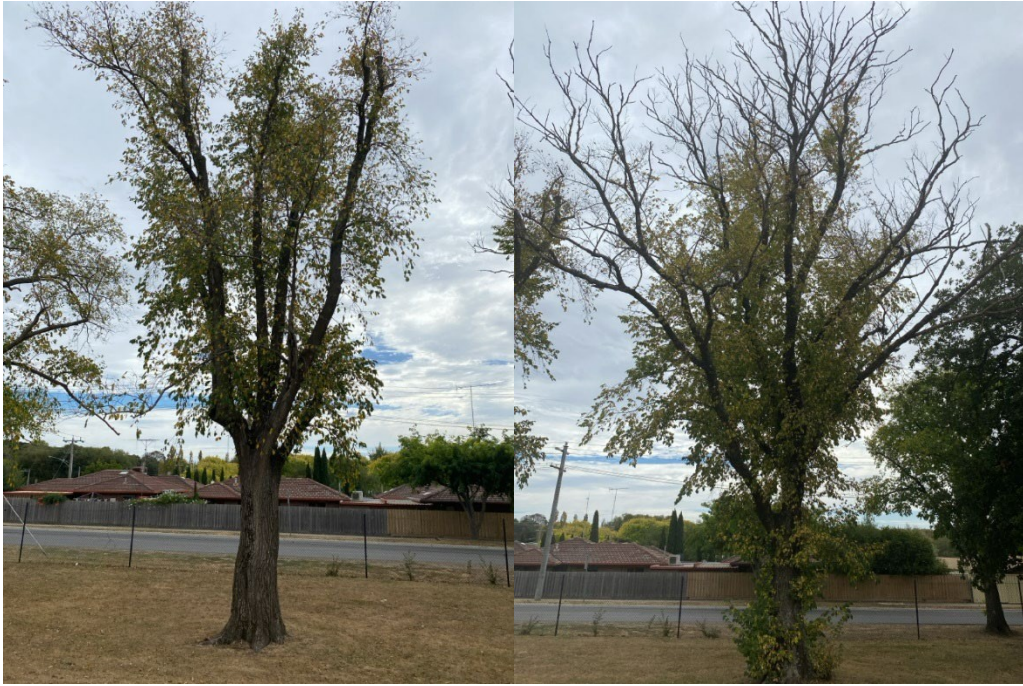
Figure 12: Photo taken of Tree 9 (Ulmus procera) in its growing environment. Image taken on 12th March 2024 by Adam Demler. Figure 13: Photo taken of Tree 10 (Ulmus procera) in its growing environment. Image taken on 12th March 2024 by Adam Demler.
