# **Preliminary Tree Assessment**

## **Macedon Ranges Shire Council**

Assessment of trees at Kyneton Showground

Thursday, 4 May 2023

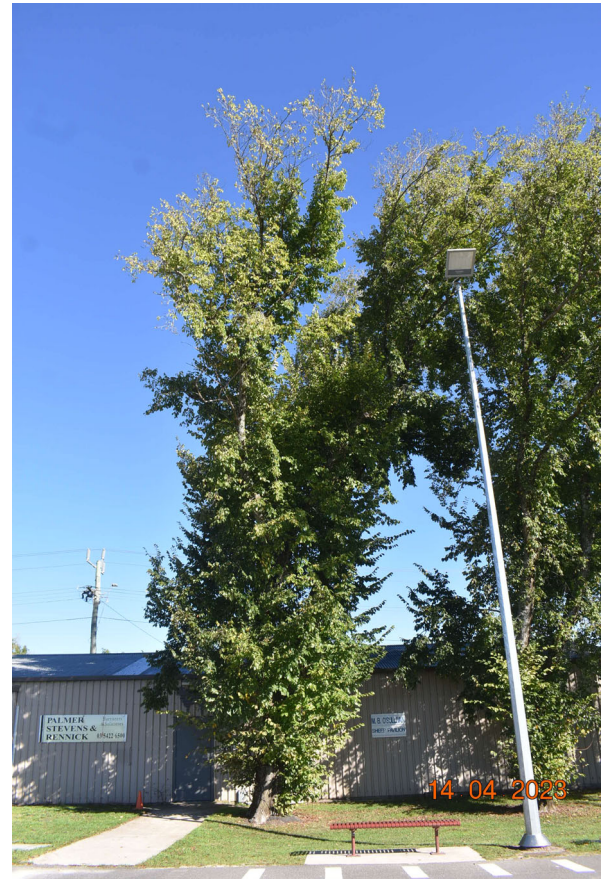
**Tree Number:** 1  
**Botanical Name:** *Ulmus procera*  
**Common Name:** English Elm  
**Origin:** Exotic  
**Maturity:** Mature  
**Height & Width (m):** 14 x 11  
**DBH (cm):** 66  
**Health:** Fair  
**Structure:** Fair  
**ULE:** 10 to 20 years  
**Landscape Contribution:** Low  
**Retention Value:** Medium  
**TPZ radius (m):** 7.92  
**SRZ radius (m):** 3.01  
**Observations:** Codominant trunks, Cavity in trunk, Deadwood

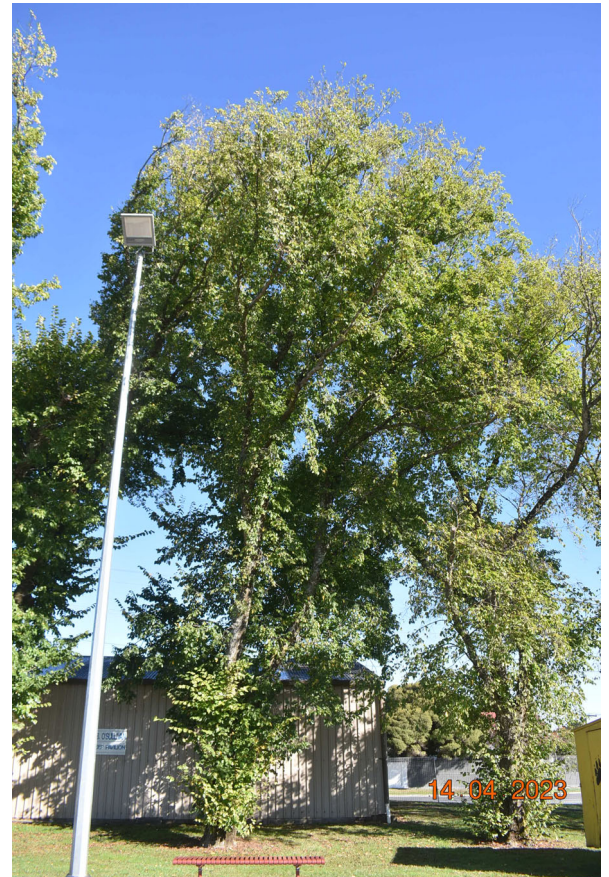
**Tree Number:** 2  
**Botanical Name:** *Ulmus procera*  
**Common Name:** English Elm  
**Origin:** Exotic  
**Maturity:** Mature  
**Height & Width (m):** 14 x 10  
**DBH (cm):** 62  
**Health:** Fair  
**Structure:** Fair  
**ULE:** 10 to 20 years  
**Landscape Contribution:** Medium  
**Retention Value:** Medium  
**TPZ radius (m):** 7.44  
**SRZ radius (m):** 2.81  
**Observations:** Codominant trunks, Decay in trunk, Trunk lopped

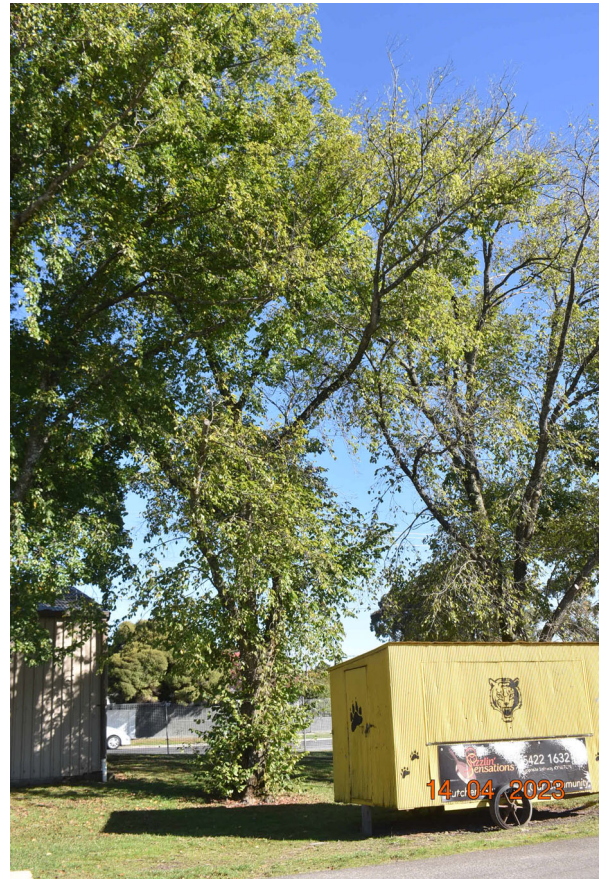
**Tree Number:** 3  
**Botanical Name:** *Ulmus procera*  
**Common Name:** English Elm  
**Origin:** Exotic  
**Maturity:** Mature  
**Height & Width (m):** 12 x 10  
**DBH (cm):** 54  
**Health:** Fair  
**Structure:** Fair  
**ULE:** 10 to 20 years  
**Landscape Contribution:** Medium  
**Retention Value:** Medium  
**TPZ radius (m):** 6.48  
**SRZ radius (m):** 2.65  
**Observations:** Extended branches in canopy,  
Deadwood

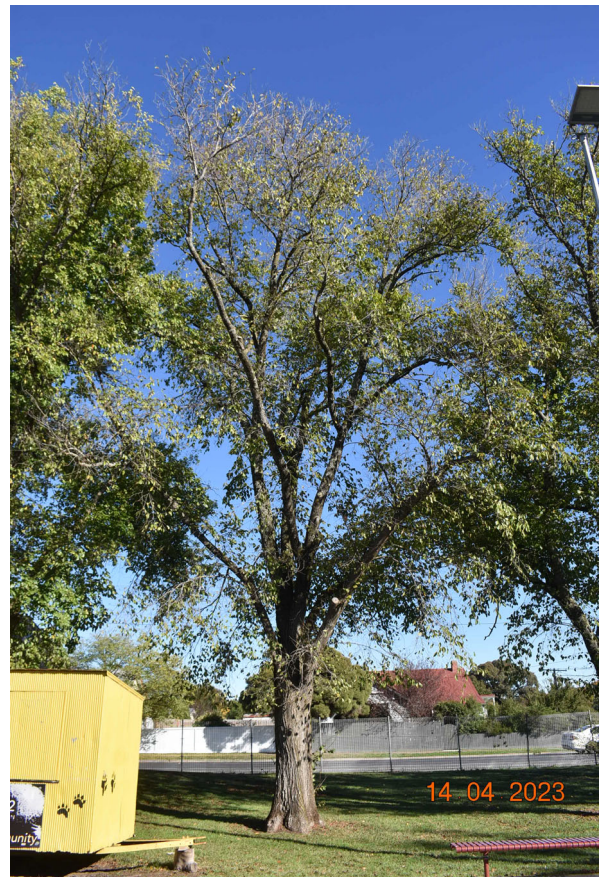
**Tree Number:** 4  
**Botanical Name:** *Ulmus procera*  
**Common Name:** English Elm  
**Origin:** Exotic  
**Maturity:** Mature  
**Height & Width (m):** 12 x 8  
**DBH (cm):** 68  
**Health:** Fair  
**Structure:** Fair  
**ULE:** 10 to 20 years  
**Landscape Contribution:** Medium  
**Retention Value:** Medium  
**TPZ radius (m):** 8.16  
**SRZ radius (m):** 3.14  
**Observations:** Mechanical damage to trunk,  
Canopy wound from previous  
failure, Deadwood

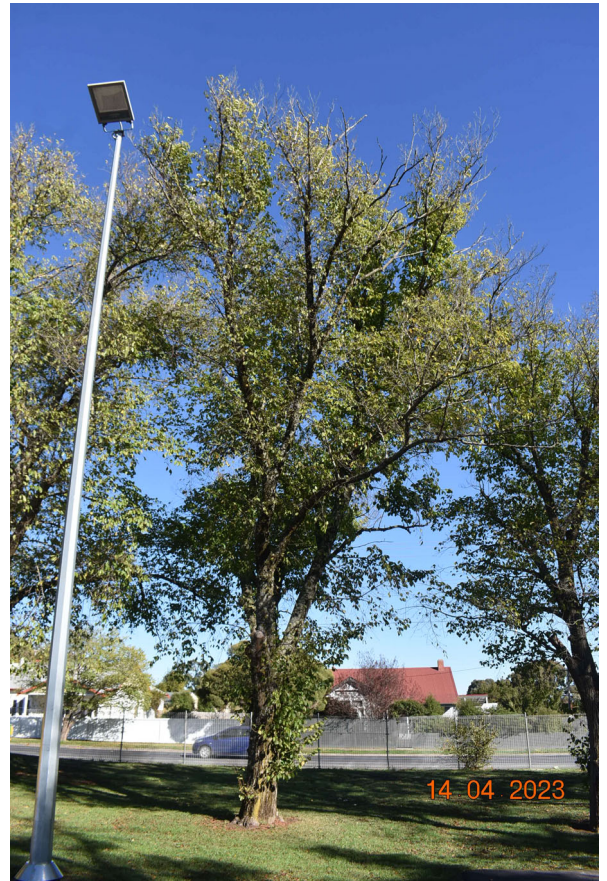
**Tree Number:** 5  
**Botanical Name:** *Ulmus procera*  
**Common Name:** English Elm  
**Origin:** Exotic  
**Maturity:** Mature  
**Height & Width (m):** 11 x 8  
**DBH (cm):** 58  
**Health:** Poor  
**Structure:** Fair  
**ULE:** 5 to 10 years  
**Landscape Contribution:** Medium  
**Retention Value:** Low  
**TPZ radius (m):** 6.96  
**SRZ radius (m):** 2.88  
**Observations:** Decay in canopy, Deadwood

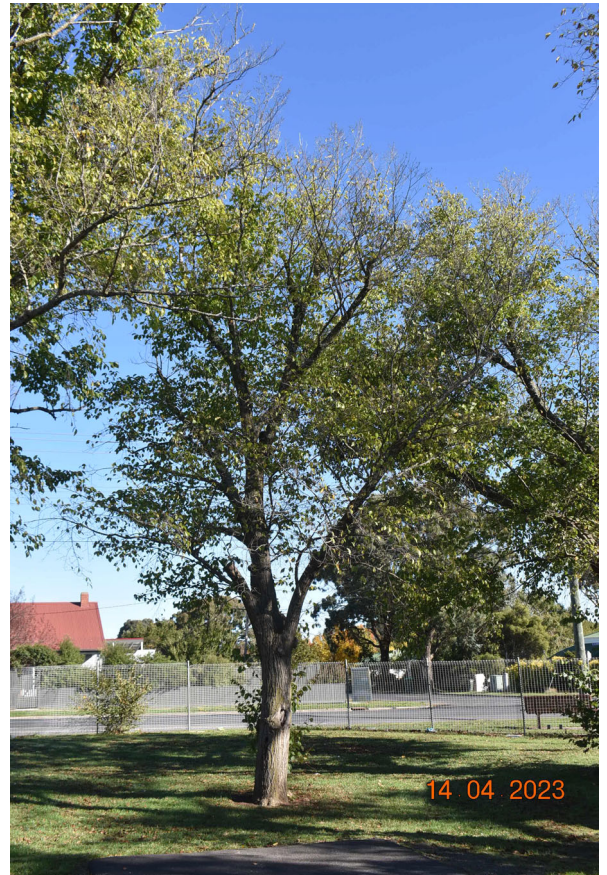
**Tree Number:** 6  
**Botanical Name:** *Ulmus procera*  
**Common Name:** English Elm  
**Origin:** Exotic  
**Maturity:** Mature  
**Height & Width (m):** 8 x 7  
**DBH (cm):** 45  
**Health:** Poor  
**Structure:** Fair  
**ULE:** 5 to 10 years  
**Landscape Contribution:** Medium  
**Retention Value:** Low  
**TPZ radius (m):** 5.4  
**SRZ radius (m):** 2.63  
**Observations:** Cavity in trunk, Mechanical damage to trunk, Decay in canopy, Canopy lopped, Deadwood

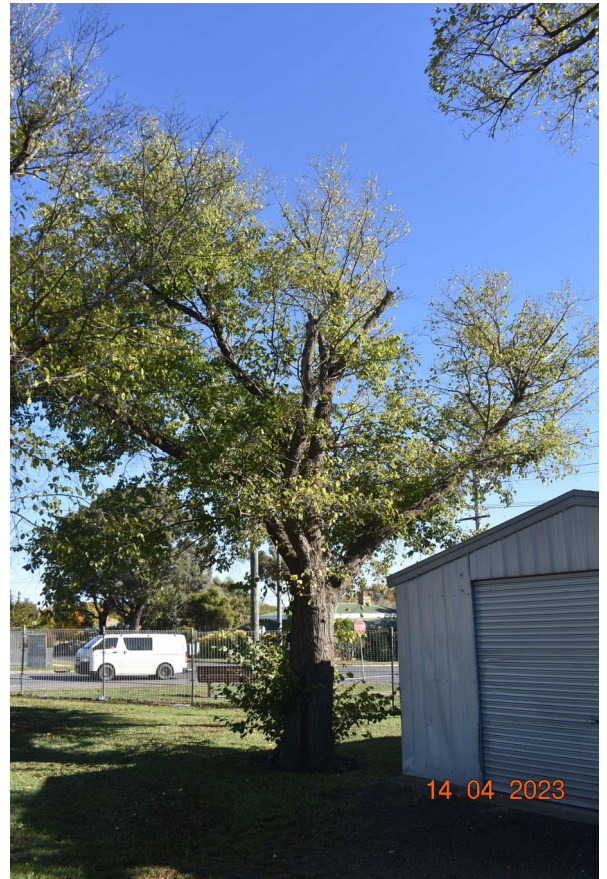
**Tree Number:** 7  
**Botanical Name:** *Ulmus procera*  
**Common Name:** English Elm  
**Origin:** Exotic  
**Maturity:** Mature  
**Height & Width (m):** 8 x 10  
**DBH (cm):** 63  
**Health:** Poor  
**Structure:** Poor  
**ULE:** 5 to 10 years  
**Landscape Contribution:** Low  
**Retention Value:** Low  
**TPZ radius (m):** 7.56  
**SRZ radius (m):** 2.97  
**Observations:** Decay in trunk, Decay in canopy, Deadwood, Canopy lopped,

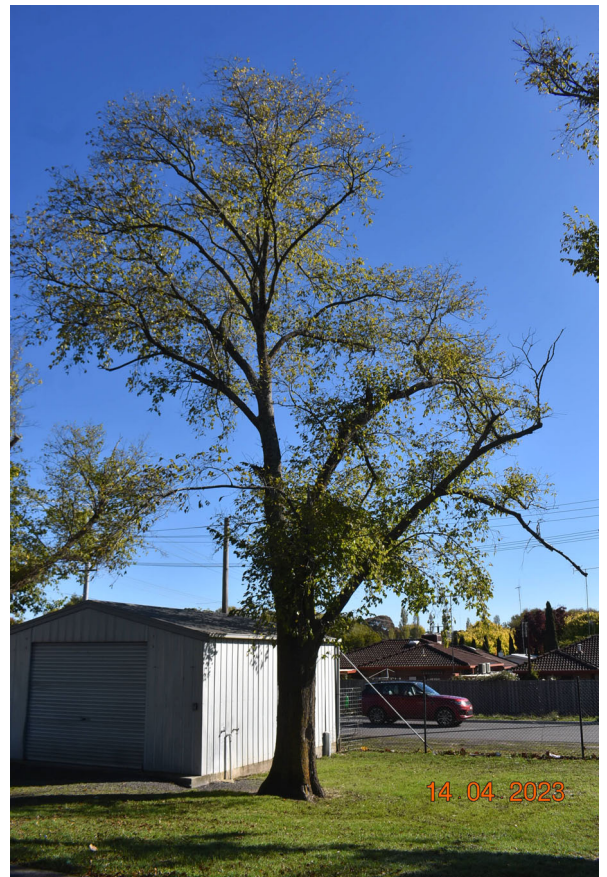
**Tree Number:** 8  
**Botanical Name:** *Ulmus procera*  
**Common Name:** English Elm  
**Origin:** Exotic  
**Maturity:** Mature  
**Height & Width (m):** 11 x 9  
**DBH (cm):** 67  
**Health:** Poor  
**Structure:** Fair  
**ULE:** 5 to 10 years  
**Landscape Contribution:** Low  
**Retention Value:** Low  
**TPZ radius (m):** 8.04  
**SRZ radius (m):** 2.98  
**Observations:** Mechanical damage to trunk, Decay in trunk, Trunk wound from previous failure, Canopy wound from previous failure, Decay in canopy, Deadwood

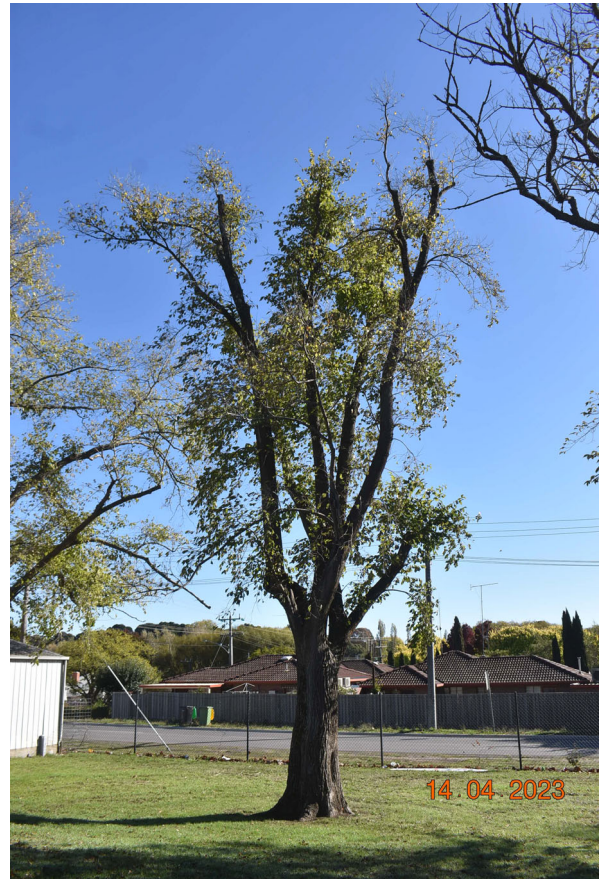
**Tree Number:** 9  
**Botanical Name:** *Ulmus procera*  
**Common Name:** English Elm  
**Origin:** Exotic  
**Maturity:** Mature  
**Height & Width (m):** 11 x 6  
**DBH (cm):** 74  
**Health:** Poor  
**Structure:** Poor  
**ULE:** Less than 5 years  
**Landscape Contribution:** Low  
**Retention Value:** Low  
**TPZ radius (m):** 8.88  
**SRZ radius (m):** 3.2  
**Observations:** Decay in trunk, Trunk wound from previous failure, Decay in canopy, Canopy lopped

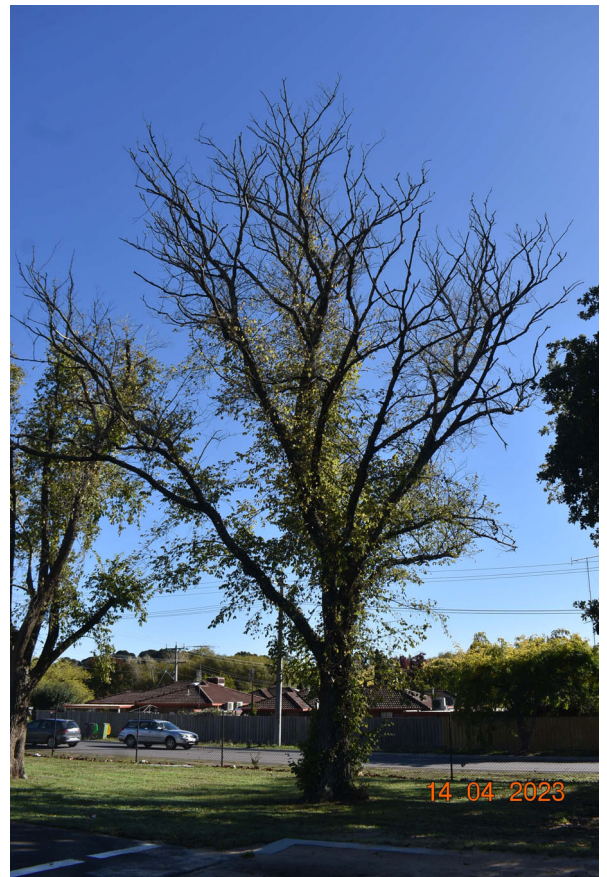
**Tree Number:** 10  
**Botanical Name:** *Ulmus procera*  
**Common Name:** English Elm  
**Origin:** Exotic  
**Maturity:** Mature  
**Height & Width (m):** 11 x 14  
**DBH (cm):** 70  
**Health:** Poor  
**Structure:** Poor  
**ULE:** Less than 5 years  
**Landscape Contribution:** Low  
**Retention Value:** Low  
**TPZ radius (m):** 8.4  
**SRZ radius (m):** 3.15  
**Observations:** Extended branches in canopy, Decay in canopy, Deadwood
