# **Preliminary Tree Assessment**

## **Macedon Ranges Shire Council**

Assessment of trees at Kyneton Showground

Thursday, 4 May 2023

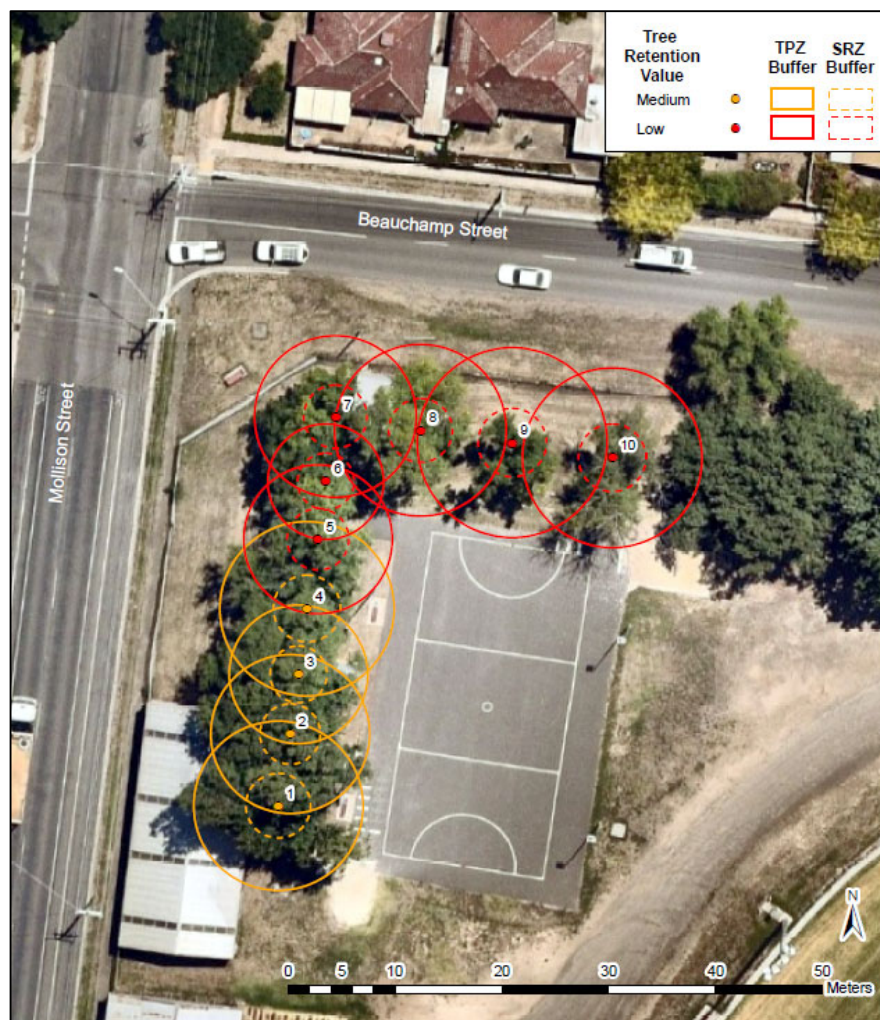
## 5. Site Plan

Four trees (Trees 1-4) have Fair health and structure and a ULE of 10-20 years. These trees have some structural defects but, with ongoing arboricultural input, have the potential to be medium-term landscape components. The trees provide a moderate contribution to the local landscape and canopy cover and have Medium retention value. Where practicable, trees with Medium retention value should be retained and protected throughout site works. Where this cannot be achieved, replacement planting should be undertaken to compensate for any amenity loss.

Six trees (Trees 5-10) have Poor health indicated by significant deadwood and decay throughout the canopy. Of these, Trees 5-8 have Fair or Poor structure and a relatively short ULE of 5-10 years. Trees 9 & 10 have Poor health and structure and are in decline, both have a ULE of less than 10 years. Trees 5-10 have Low retention value; such trees are generally not considered worthy of impeding development and tree protection measures would not need to be considered in any future development design.

10 English Elm trees were assessed at the Kyneton showground. Four trees are in fair condition and have Medium retention value. Six trees are in fair or poor condition and have Low retention value.
