Wednesday, 3 April 2024

Reference: JN7174

**Quantified Tree Risk Assessment Report on Ten (10) trees at Kyneton Show Grounds
184 Mollison Street Kyneton 3444.**

Quantified Tree Risk Assessment Report

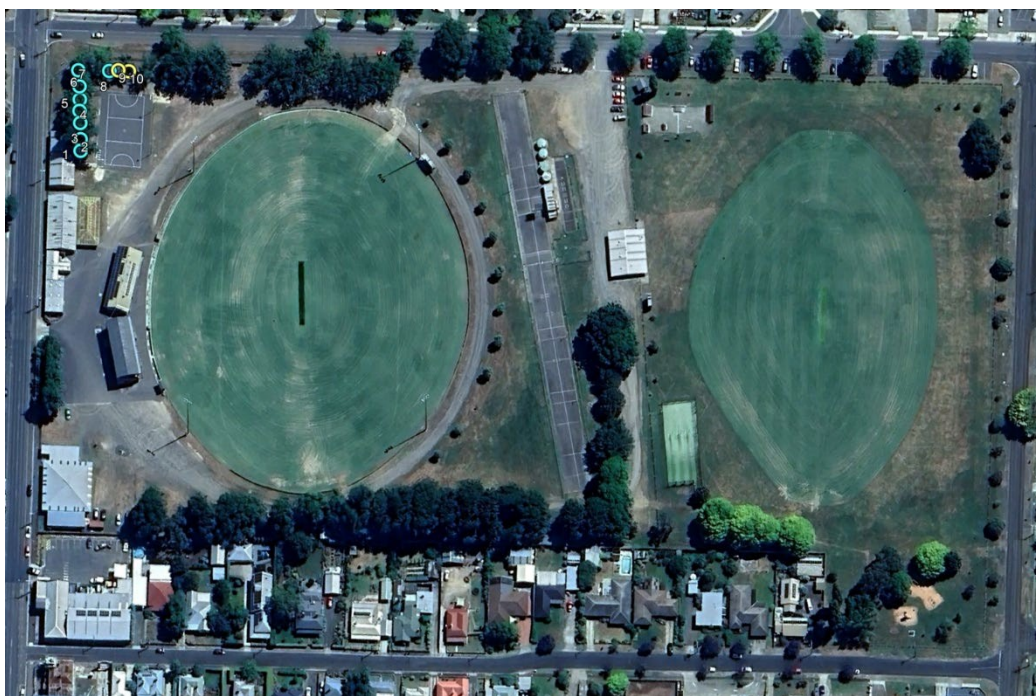
Figure 1: Aerial image of the site for identifying the tree(s) on-site. Image sourced from Google Earth. Imagery dated 13/01/2023.

3.3 The subject trees are marked up on an aerial image in Figure 1 to facilitate on-site identification. The trees have a unique identification (ID) number adapted by the Homewood report. The trees have been assigned unique names by the Kyneton and District Town Square Co-Op which are referenced in the Tree Inspection Schedule below. No trees are physically tagged on-site.
